# **Jisr – El – Zarka**

**Summary of ten years  
monitoring**

**Dr. Yaacov Nathan  
Geological Survey Israel**

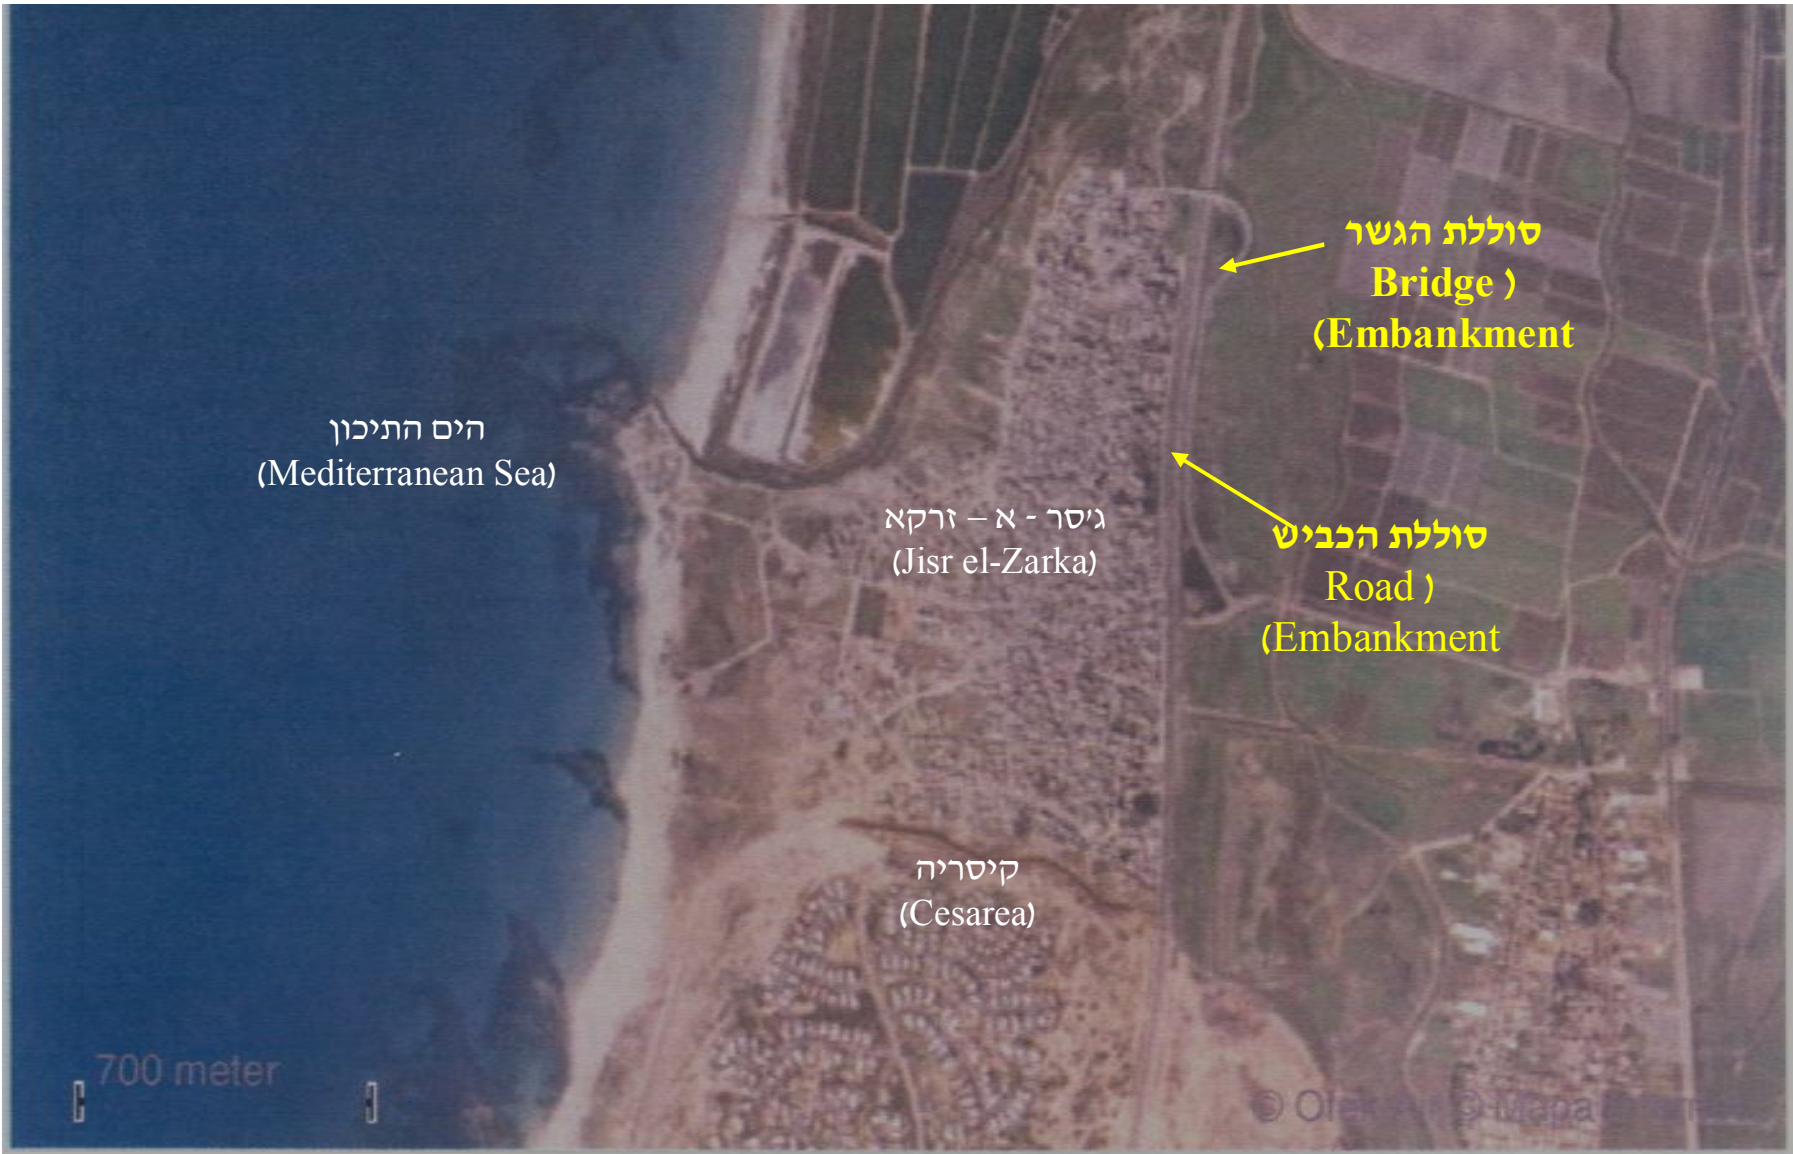
ג'סר - א - זרקא  
(Jisr el-Zarka)

סוללת הגשר  
Bridge )  
(Embankment

סוללת הכביש  
Road )  
(Embankment

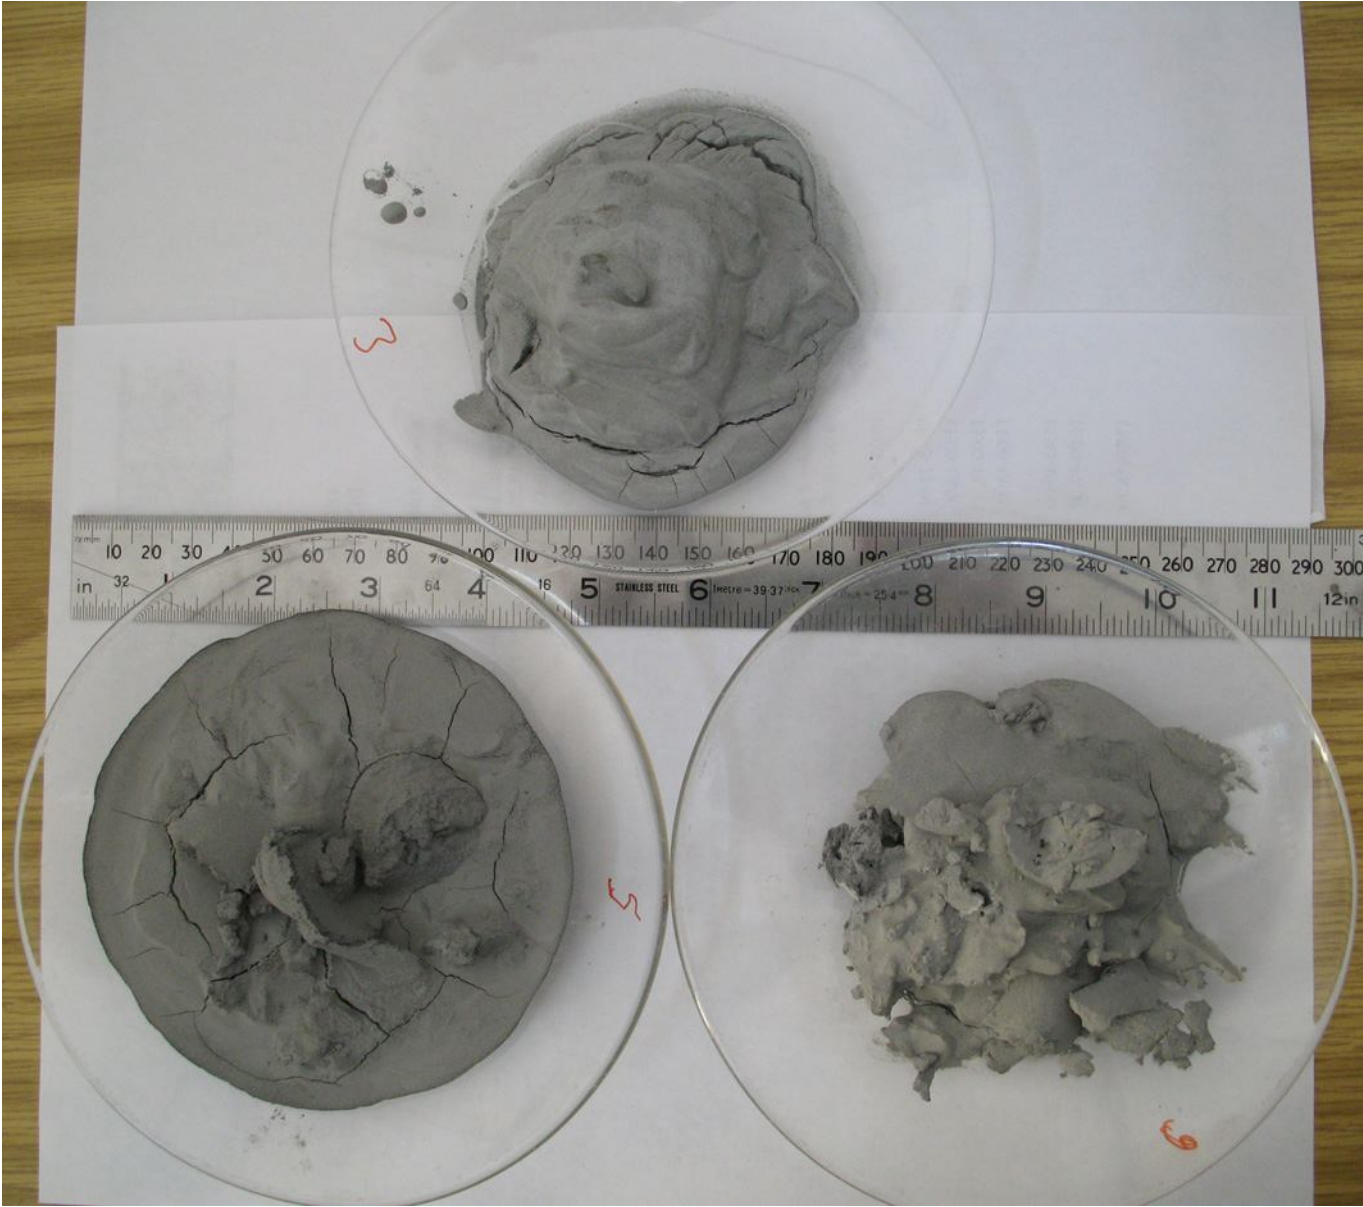
## Infiltration rates in Road 6

**The results obtained from the ash at road 6 and in laboratory experiments confirm what was observed in Jisr: coal fly ash after absorbing and reacting with water and CO<sub>2</sub>, forms with time a practically impermeable mass.**

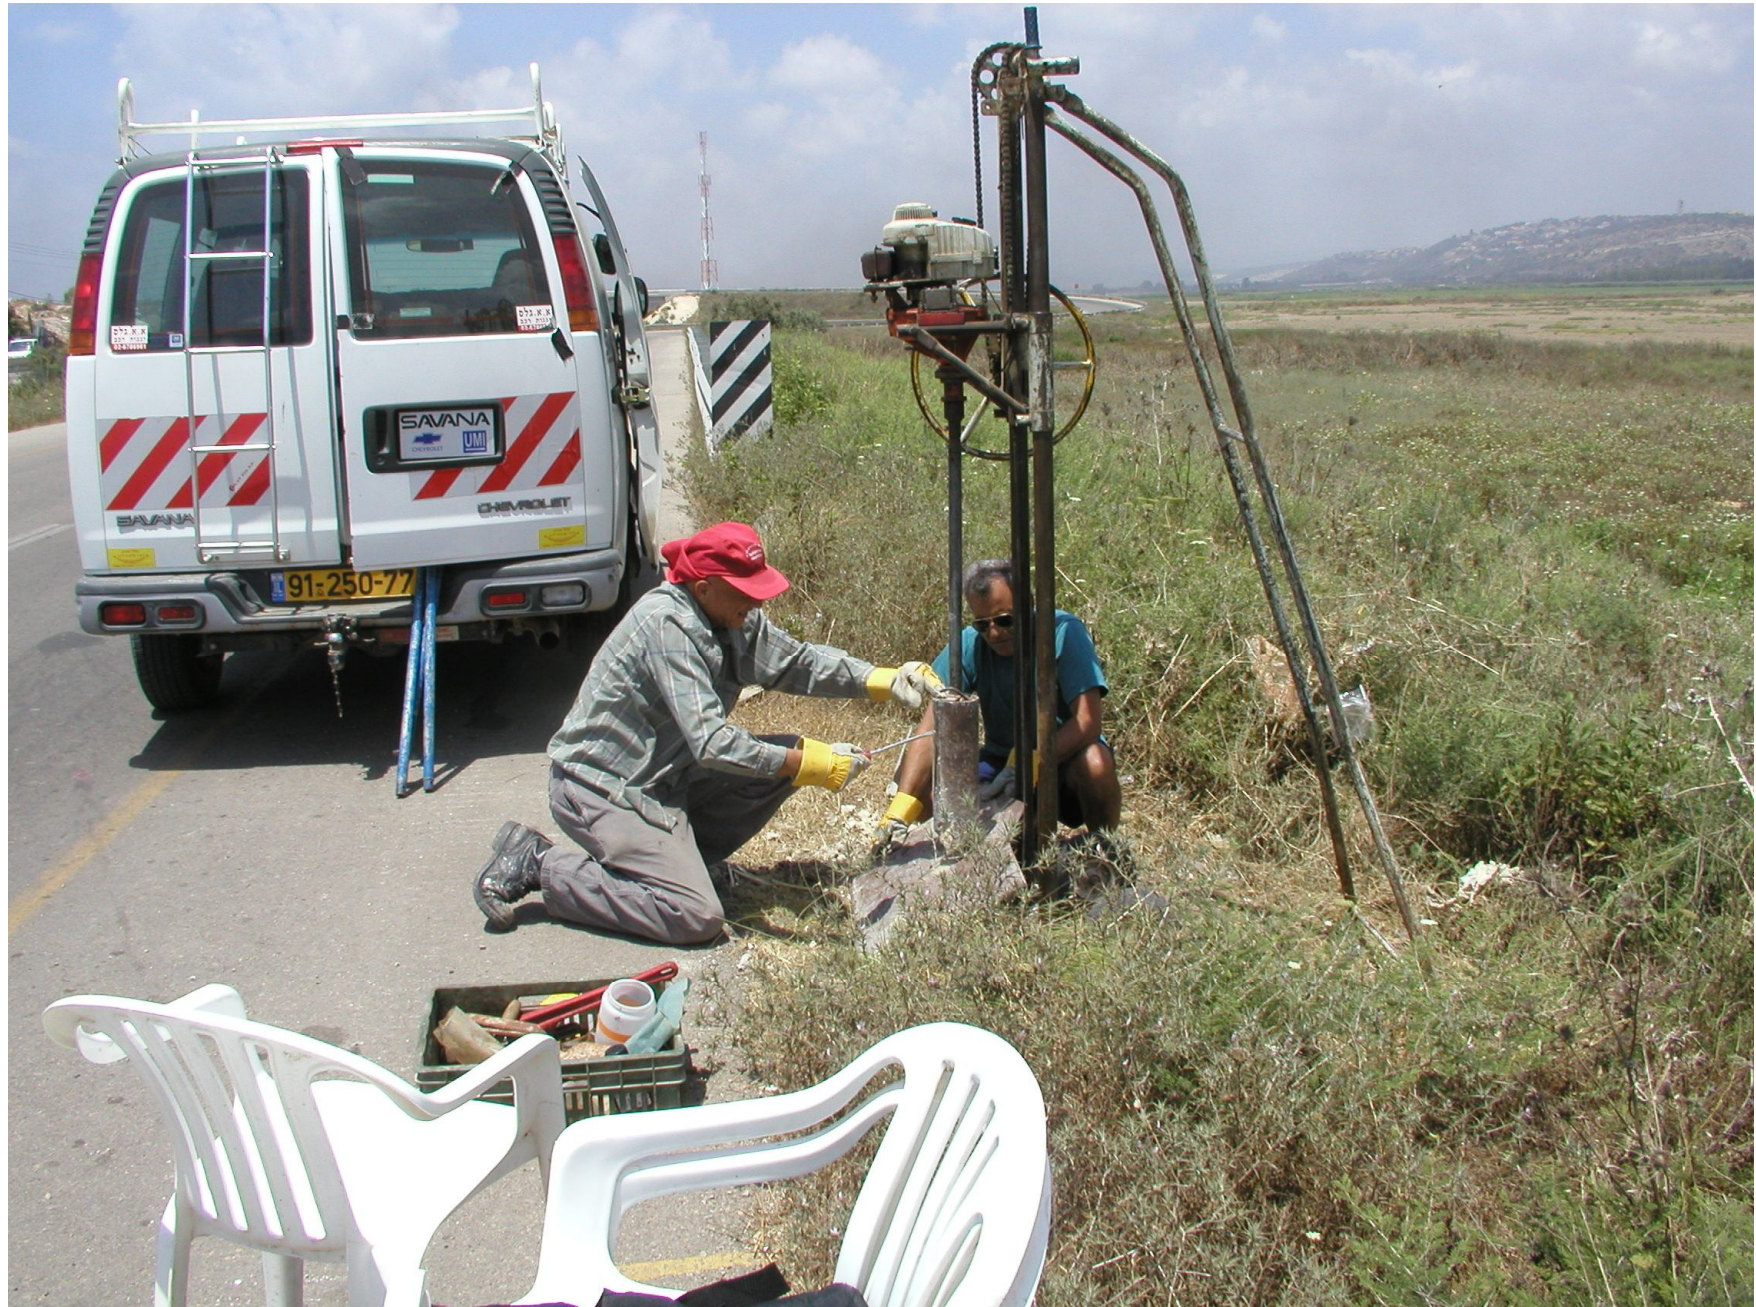
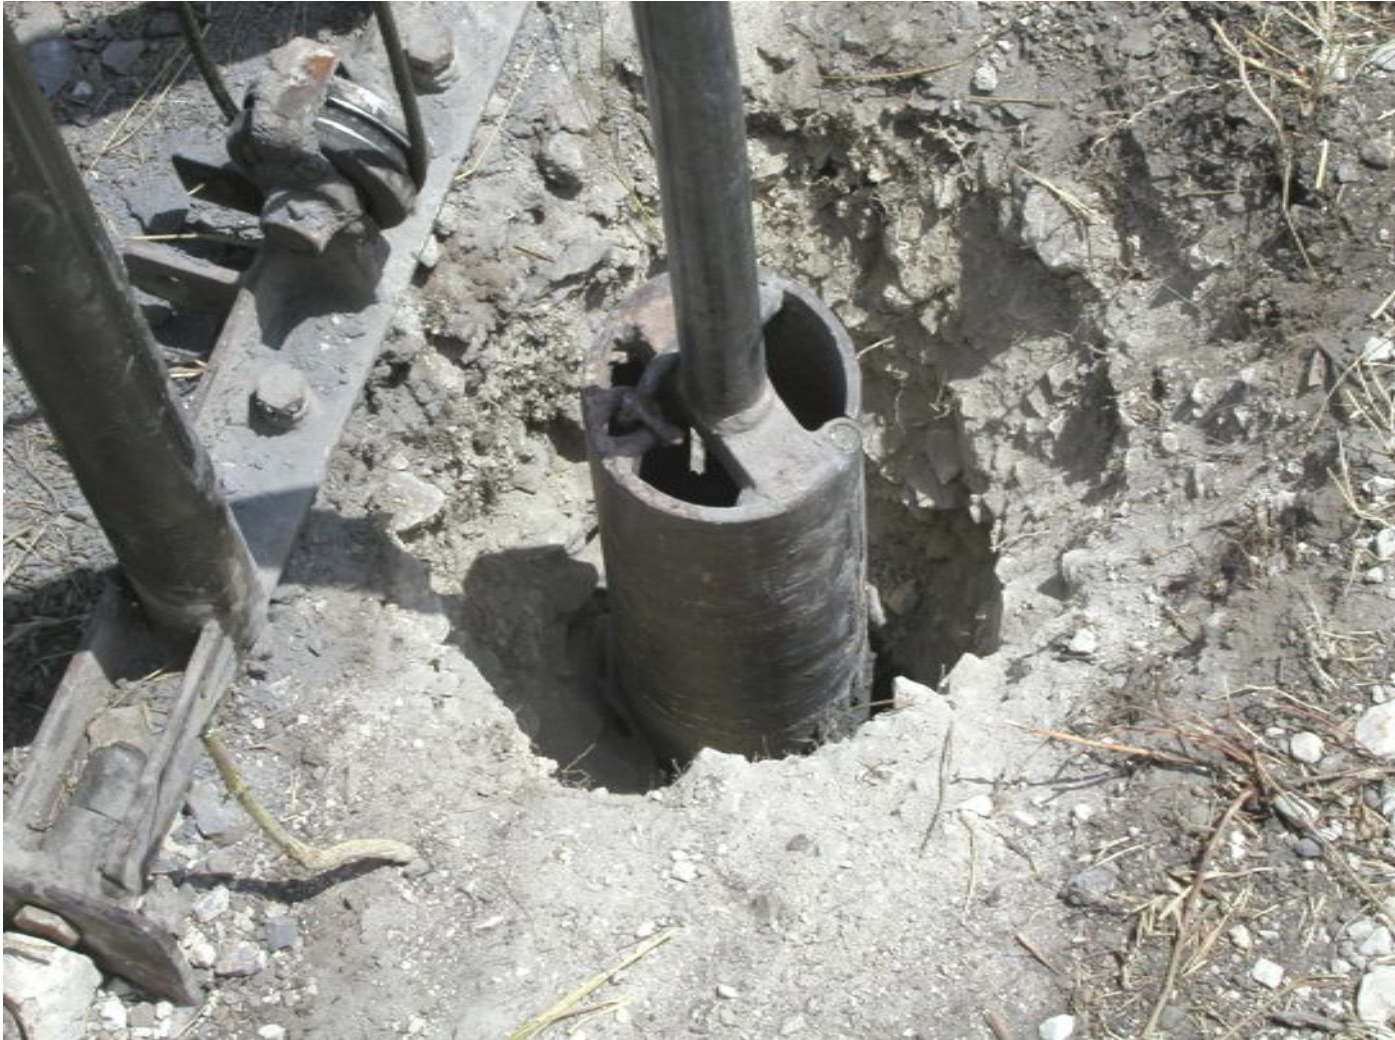
**The drill at the bridge embankment was problematic. The first trial was on July 27<sup>th</sup>. 2006. After half an hour of difficult drilling, the hard tip of the drill broke. After changing to a larger one, it broke down again almost immediately. The second trial was on the 5<sup>th</sup> September 2006, after repairing the two drills and sharpening them. It was difficult to drill with the small drill and the larger was used. We were able to drill to a depth of 160 cm. Then a harder layer occurred which caused the breaking of the drill. The sampling was completed only on the 13<sup>th</sup> March 2007, using a “spiral” drill in the hard layers.**

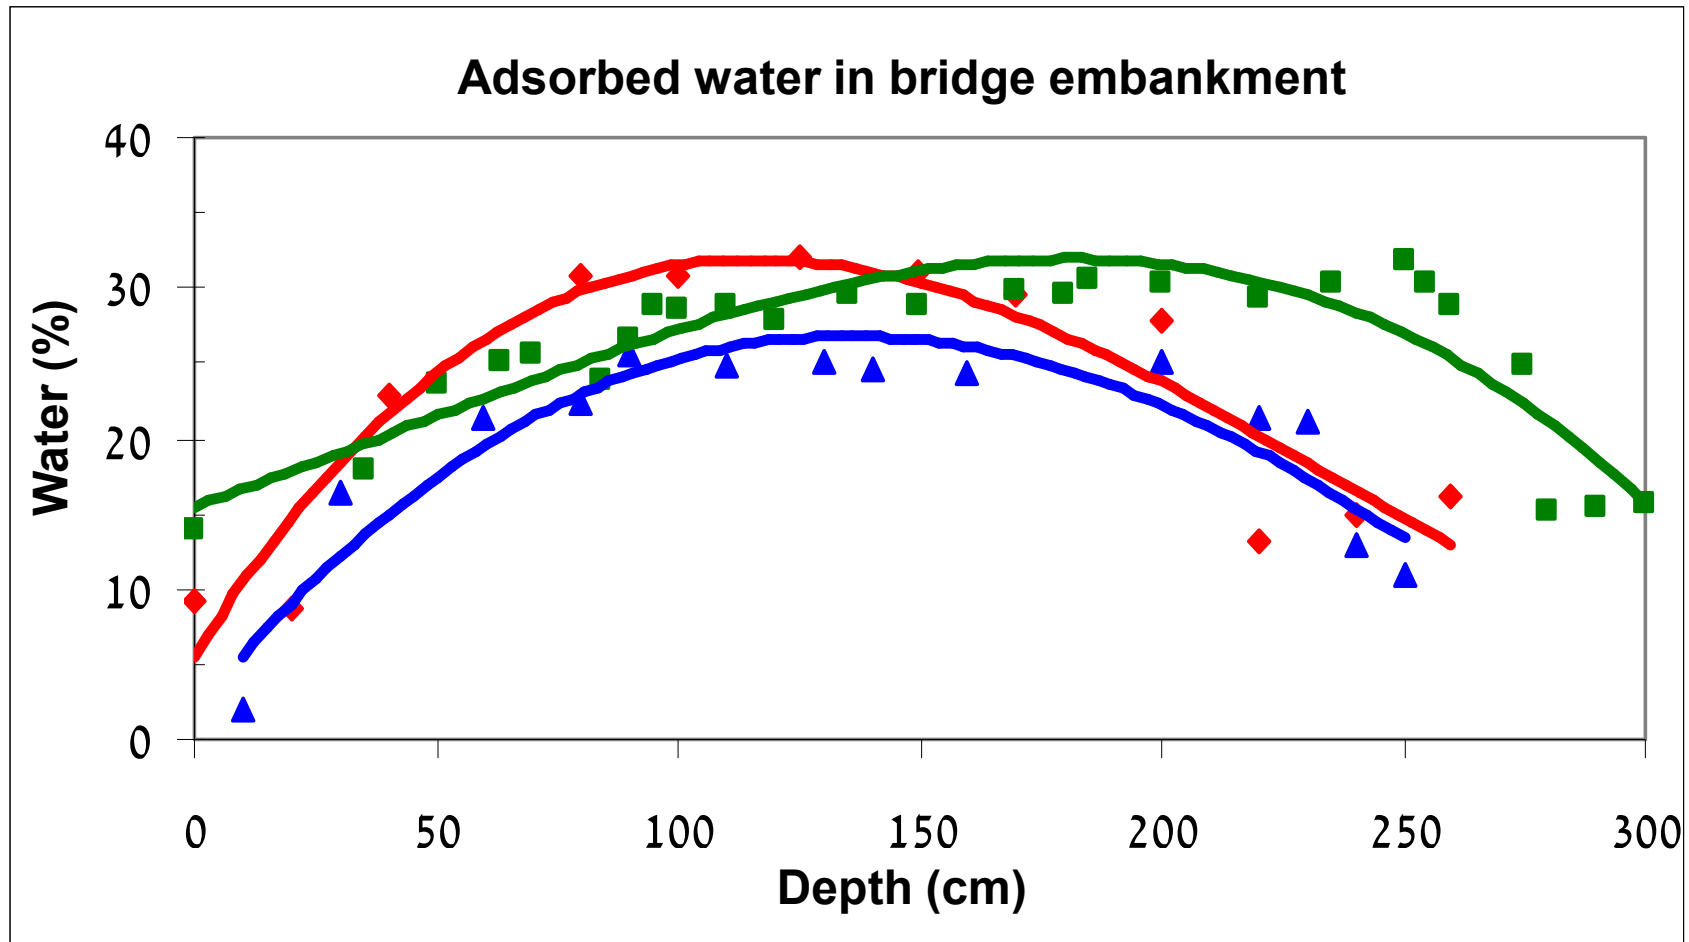
**Blue triangle – sampling in 2000**

**Red diamond – sampling in 2003**

**Green square – sampling in 2006**
